LI-1800 Spectroradiometer will not communicate or will not power on

To examine possible communication errors:

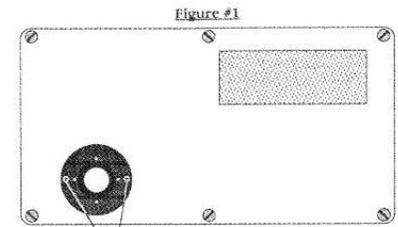
Remove these two screws and remove the Cosine Receptor

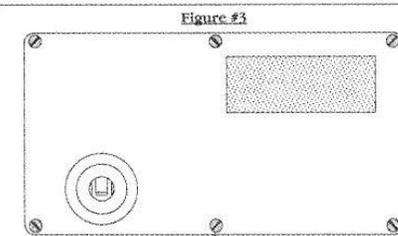
Loosen the six lid retaining screws and remove lid
